**Report**

Officer: Clare Turner - Town Clerk  
Date: 12<sup>th</sup> July 2023  
Meeting: Town Council – 18<sup>th</sup> July 2023

**Maintenance Work Area**

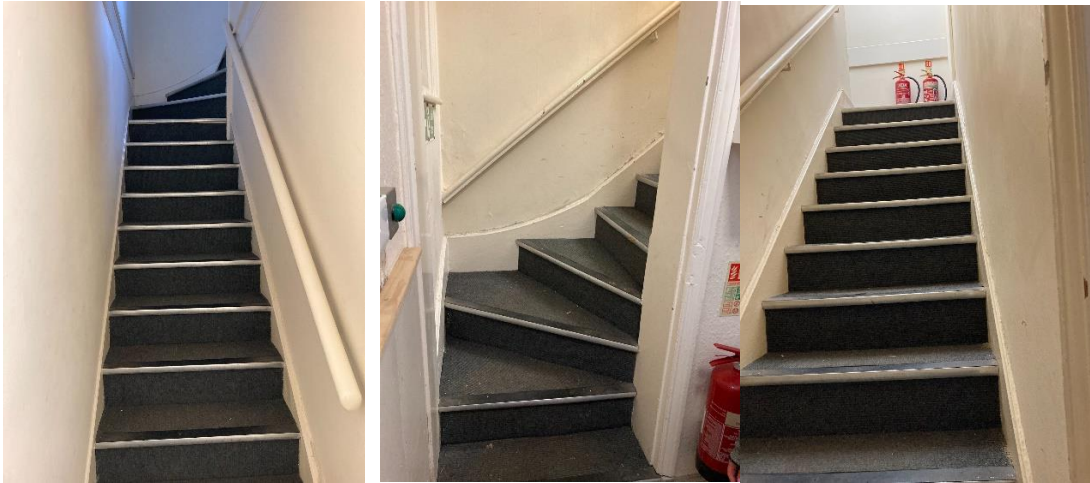
Appendix A.

The use of this building includes the Maintenance Team having to access this work space via two very steep staircases and at times this is while carrying tools, heavy equipment and large items of wooden board, as well as manoeuvring around a tight bend to access the second set of stairs on a small landing area.

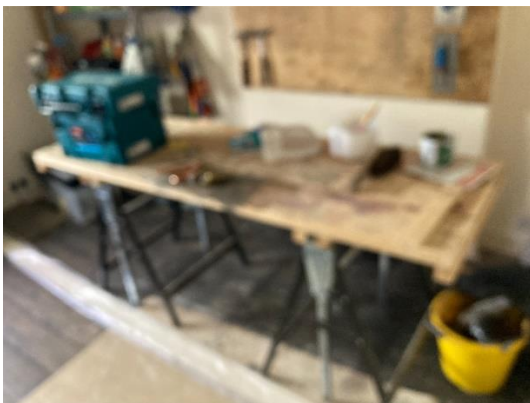
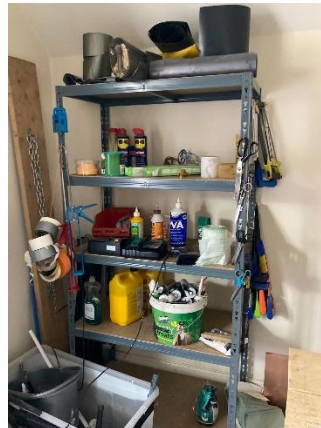
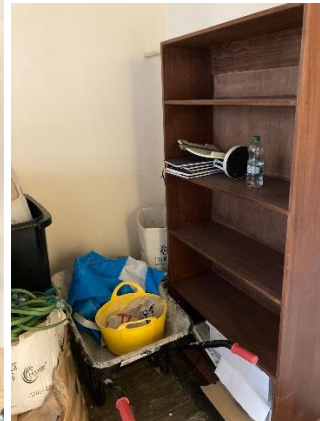
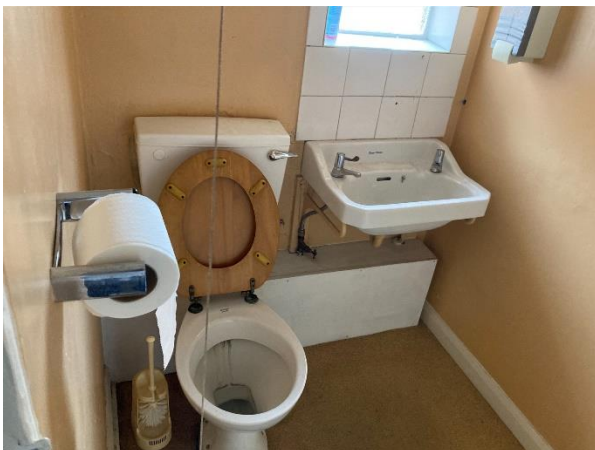
Attachment B.

- Access staircase is very narrow and difficult to manoeuvre boards required to be cut on second floor
- Access staircase is very difficult to manoeuvre when us carrying heavy equipment such as drills / saws to and from site for storage

- Very little ventilation when using electrical saws to cut wooden boards, etc
- No proper work bench provided, a work bench has been created using some timber and trestle legs. There is no fixed locking devices in place when cutting boards

- Trips / Slips and Falls are an issue in this area as there is only uneven floorboards as covering for the floor in the individual rooms used
- Incorrect storage of items that require locked storage due to hazardous and no CoSHH data sheets for substances used

- Out of data first aid kit
- Handwash facilities and WC provision is poor and not on a cleaning schedule
- No kitchen facilities to provide clean / safe area to take breaks / lunch

- There are other items both Town Council and outside the organisation being stored in the same area
- Isolated area if loan working or an accident were to occur

- Removal of existing wooden shed
- Concrete base to be placed in area
- Electricity supply to be taken from the DLF canteen
- Purchase of a new metal garage in green to be located in the space to include appropriate locking devices
- Purchase of a new metal shed in green to be located next to the new metal garage to be used as storage to include appropriate locking devices
- Internal cladding to include insulation
- Lighting and electrical sockets to be installed
- Ventilation to be considered and installed
- Purchase of an appropriate work bench
- Provide appropriate storage for electrical equipment
- Provide appropriate storage for any hazardous substances and CoSHH data sheets
- Move maintenance equipment items to new work area
